# TB078 (Rev1) - Common Wiring Problems

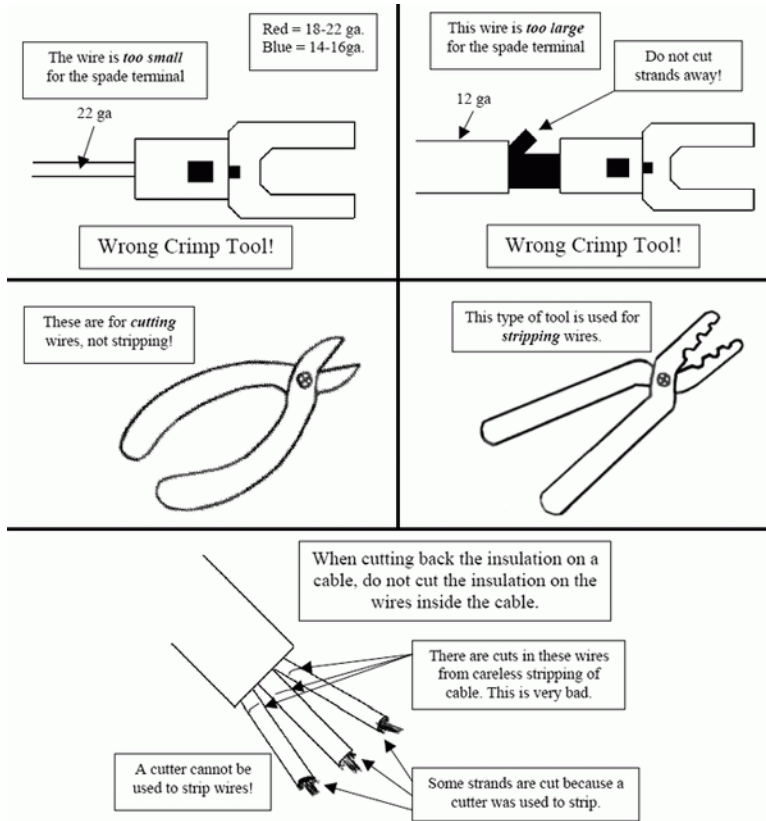
This picture shows some of the wiring problems that have been found in Centroid controls. Steps **must** be taken to avoid these problems.
