TB088 (Rev1) - Recommended Coupling for Direct Drive Transmissions

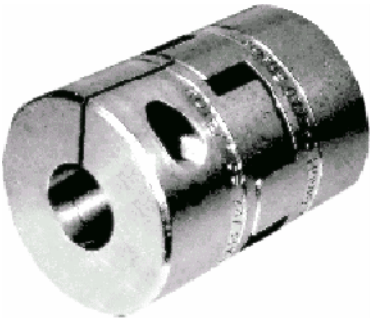
Replacement Coupler's

Currently some machine tool builders are using a direct coupler that is misaligned and can come loose, this coupler causes a very noisy racket that sounds like a machine gun firing, giving the false impression of a bad motor.

KTR Rotex GS model, coupler size 28/38. It is silver in appearance and uses a red poly coupling. KTR's phone # is 219-872-9100 and their Email: KTRcorp@ktrcorp.com (www.ktrcorp.com)

The best solution is to use a proper coupler. Both KTR and Zero-Max can supply you with an excellent coupler.

Zero-Max, Inc. Servo Class # SC 050. Their phone # 1-800-533-1731
